G-CREWS 04/June/2024

TECHNICAL ASSESSMENT REPORT – BLAIZE RAINWATER HARVESTING

Allen Gilbert, GIZ GD – Senior Technical Advisor
GIZ GMBH

TECHNICAL REPORT – ASSESSMENT OF BLAIZE RAINWATER HARVESTING SYSTEM

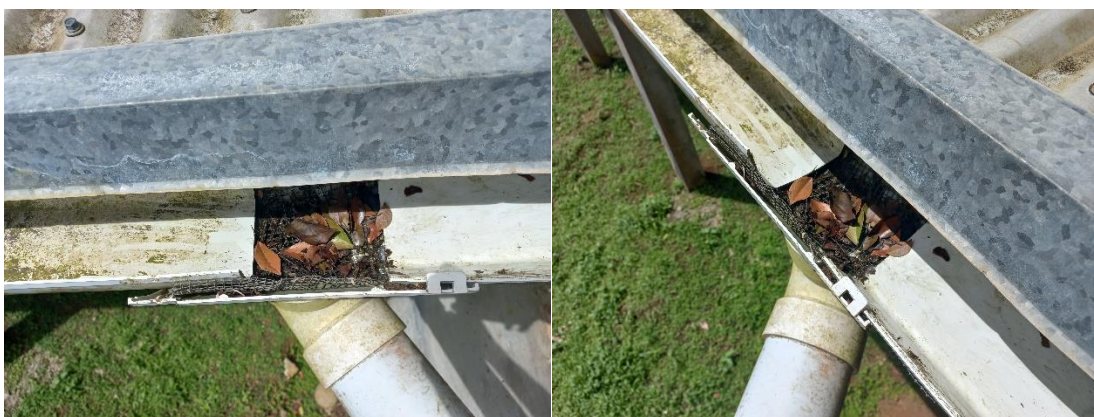
- Investigation and information provided by NAWASA management and supervisory team, indicated that an operator frequently visits the site to take care of the system, and ensure that chlorine residual amounts are within limits, and do landscaping maintenance. However, there is no indication of frequent cleaning of the guttering, as this is critically important for roof catchment to RWH systems. During a site visit, it was noted that both water collection downspouts were almost completely blocked with leaves (see Figure 4.1 below). It was also noticed that a significant part of the guttering was broken off and left unrepaired.

Figure 4.1 - photos showing leaves in guttering at Blaize.

- Little or no maintenance of the guttering system. Rainwater harvesting systems, designed with roofs in areas with trees, always require frequent cleaning of the guttering and downpipe collection chambers. When the site was visited to conduct this assessment (October 2022), downspout collection chambers were blocked with leaves on the mesh wire was placed to prevent the leaves from entering the downpipes (see Figure 4.1). Additionally, it was noted that operators do not have a schedule for cleaning the guttering, and it's not a practice of theirs to do so.

- Remove all existing guttering and install a much more durable guttering system, with a suitable profile for effective water collection. Fasteners should be of stainless steel, brass or non-ferrous materials.
- Develop and implement a vigorous maintenance schedule or standard operating procedure (SOP) for cleaning of the guttering and maintenance of the system.
- Fiberglass covers need to be analysed for toxins or carcinogens, as they have been seen to be producing a white powder (see Figure 6.2) on the top of manholes, possibly from abrasion when the covers are removed and replaced. If proven dangerous they should be replaced with a better system (see Ch 16. and Figure 6.3)

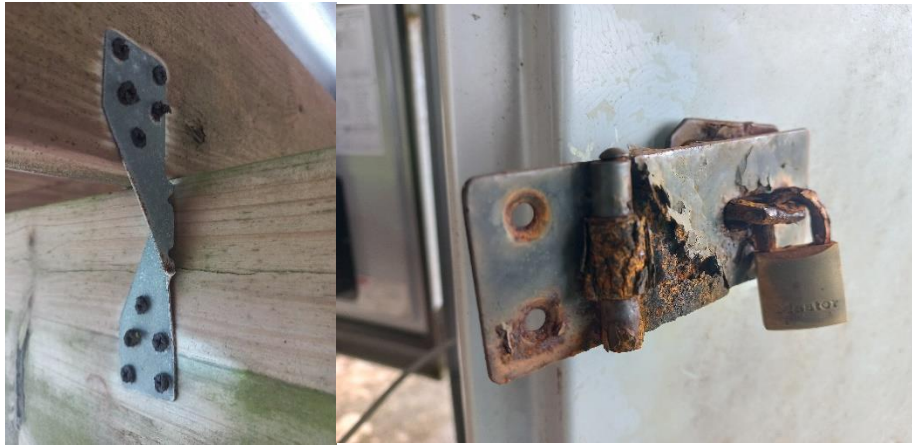
- Location is conducive to corrosion of metal components, due to the high moisture in the atmosphere at that elevation and sodium chloride from the ocean breeze.

Figure 4.2 - Photos showing corrosion of screws and equipment latch at Blaize

- Stainless steel roofing brackets are encouraged or at least a good alloy bracket that is resistant to corrosion.
- All fasteners (screws, nails and bolts) should be stainless steel (see Figure 4.2).

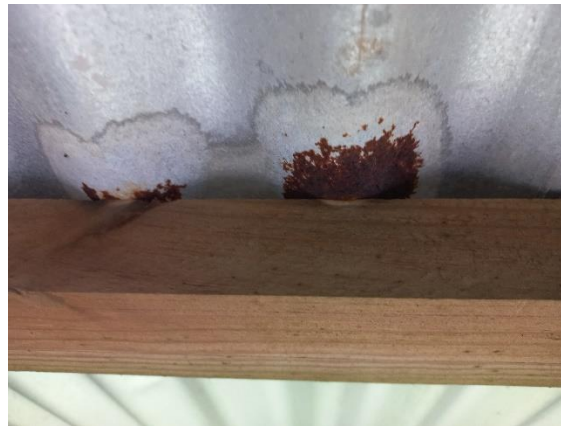
Figure 4.3 - Photo showing corrosion to the underside of roof sheeting where it sits on purlins

- Roof sheeting should be from galvanize, aluzinc, galvalume or similar material and to be coated with paint or epoxy coating on the underside. Moisture in most RWH systems locations are absorbed by the timber and causes corrosion to the underside of the sheeting (see Figure 4.3).

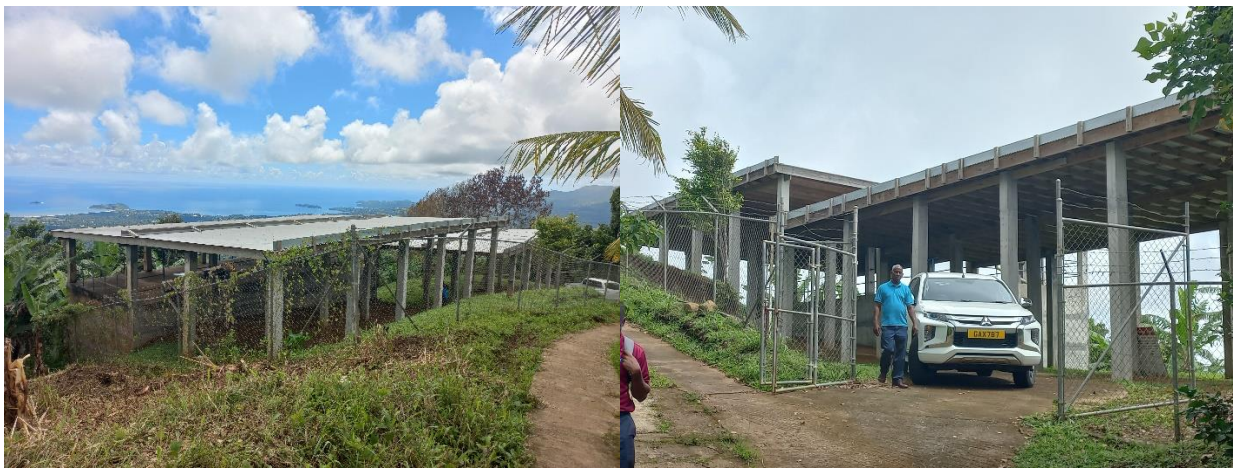
- The additional roof of 1,286.25 sq-ft. (119.5m²) was constructed and connected to the tank.

Figure 5.1 - Photo of Blaize RWH system showing both roofs

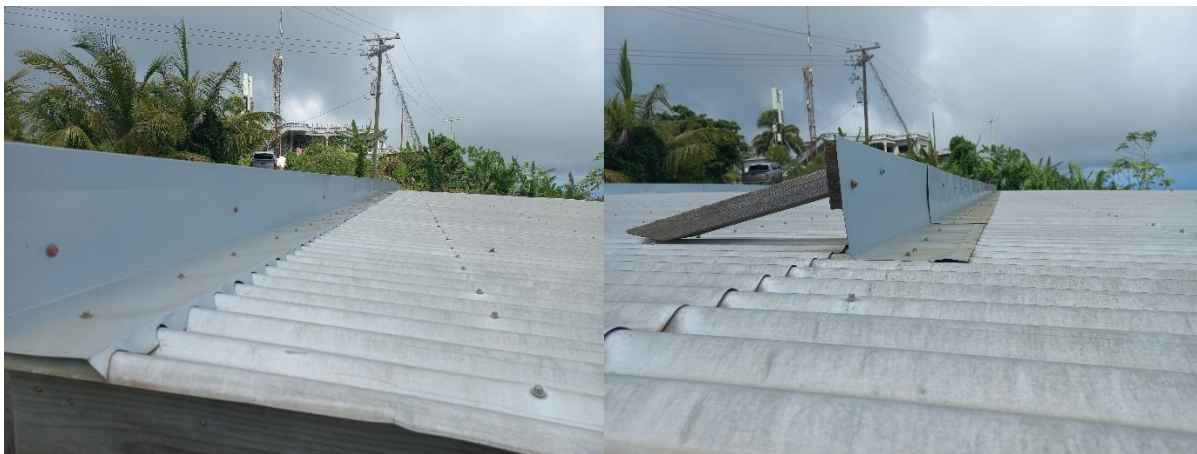
- "L" shaped galvanize rain stops, with a vertical portion of approximately 8" were affixed, perpendicular to the slope of the roof to minimize rain fall fly away (see Figure 5.2).

Figure 5.2 - Photos showing "L" shaped rain stops installed to prevent rainwater flying away

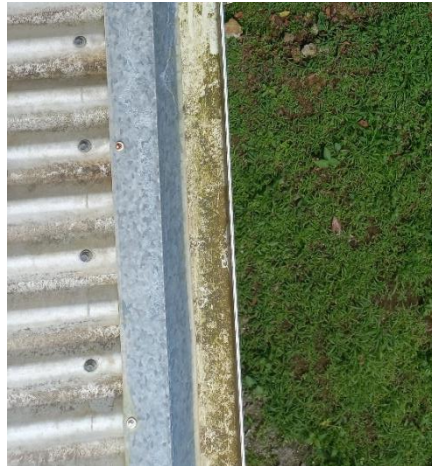
- Drip edge galvanize flashing was installed to allow runoff water to fall directly into guttering and prevent loss.

Figure 5.3 - Photo showing drip edge installed to improve collection of water into guttering

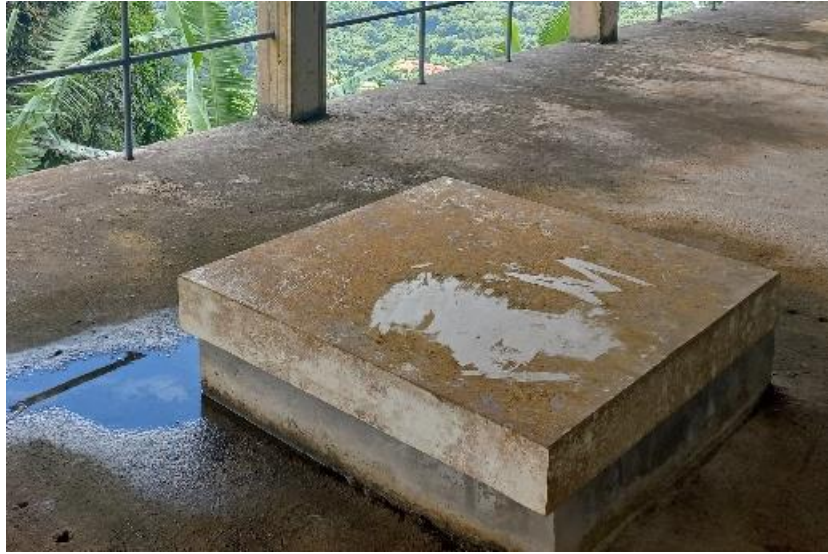
Figure 6.1 - Photo showing fibreglass manholes cover

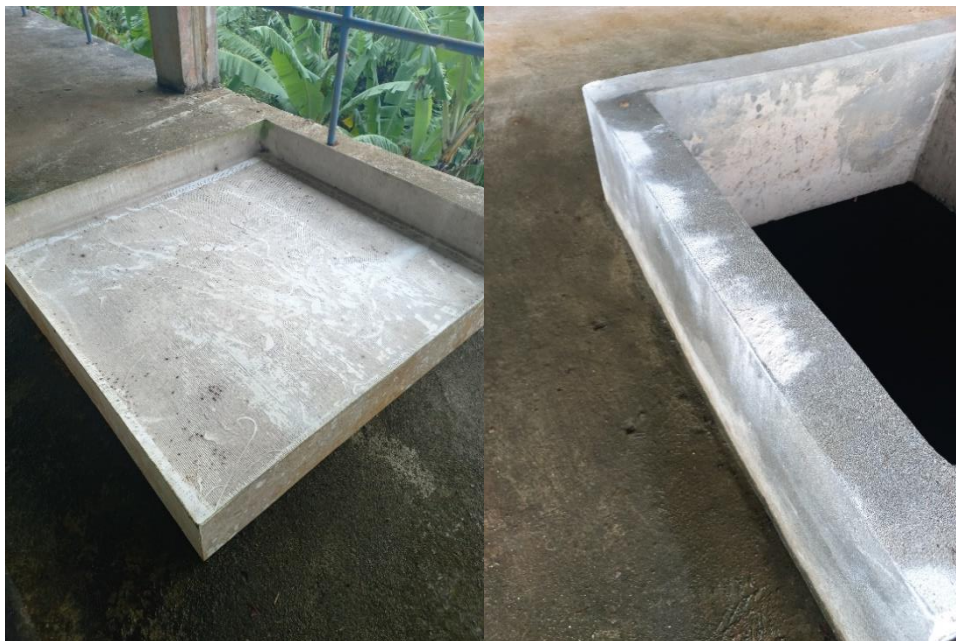
Figure 6.2 - Photos showing powder substance under manhole covers and manhole walls

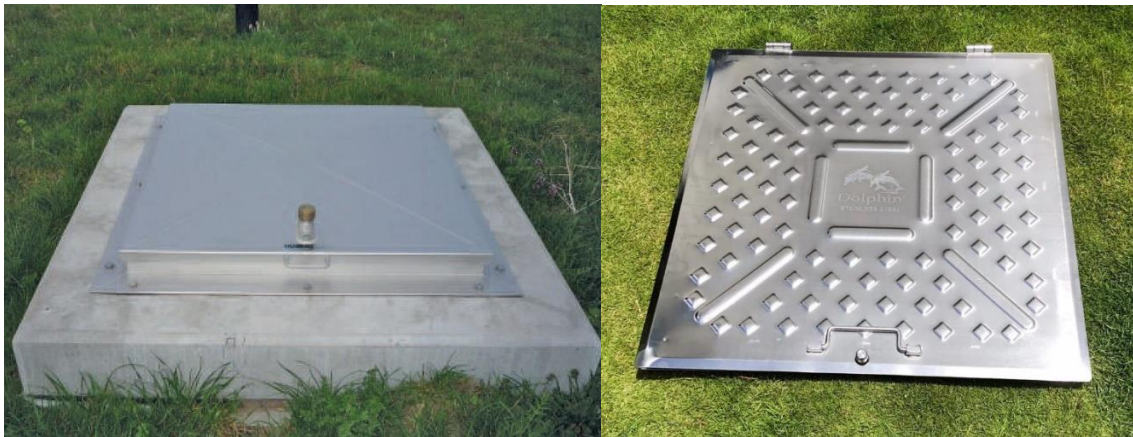
Figure 6.3 - Proposed stainless manhole cover options (see Photo Credits pg. 18)

- Air & watertight, tamperproof manhole covers, with fall prevention grill/grating should be the preferred options similar to images shown below.
